Qualitative Study Agrarian Soil Contaminated by Crude Oil in the Town of the North-East of Algeria

The qualitative study of soils contaminated by crude oil was essentially based on the survey and observation of the different plots from arable cropping patterns. It aims to establish a diagnosis on the state of soil contaminated with crude oil spilled accidentally during a break in a section of the pipeline that runs through farms in the town of Ain Smara in the nord-east Algeria

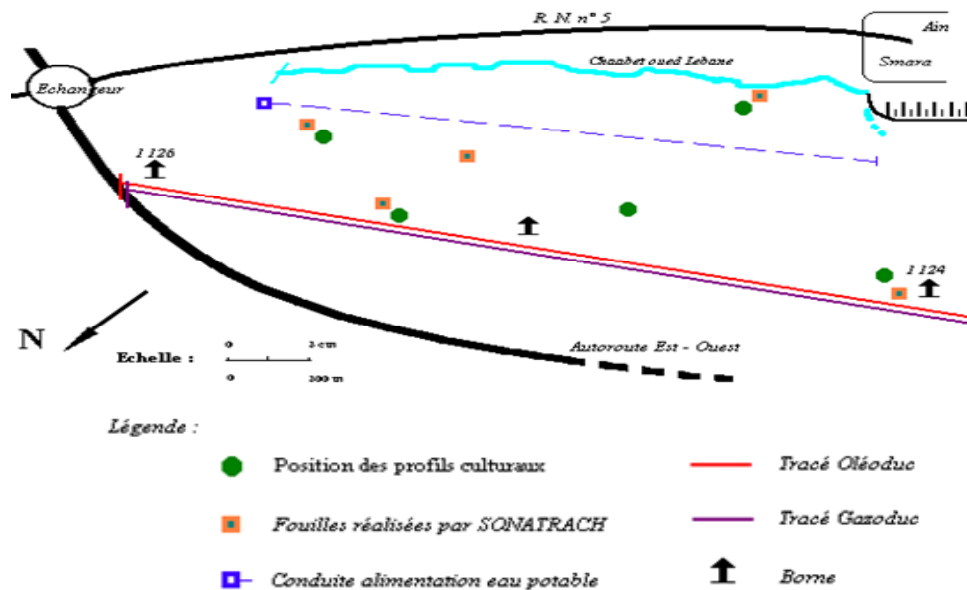
Figure 4: Positioning cropping patterns (Landscape Architecture2004 Ltd.)

The study soil that we have firm aims to detect the possible presence of crude oil in different backgrounds at the morphological description of cropping patterns. It is based primarily on the statement and visual observation of the different plots from arable cropping patterns. The latter aims to establish a diagnosis of the state of the ground. It enables analysis qualitatively succession of these diverse backgrounds and determine their properties. Using the same cultural profile, we can establish the presence or absence of an exogenous factor that is not part and parcel of ground for a pollutant or contaminant [6]. Choice of positioning Profiles cropping is not random. This choice is dictated more by a concern for soil pollution. It is for this sole reason that we have positioned cropping patterns where the presence of crude oil was discovered during excavations in the basement. These were carried out by SONATRACH (Regional Direction of Transportation Pipeline) (Figure 4). To arrive at a perfect knowledge of the ground, at a farming profile must be added by the quantitative analyses of the ground [7].

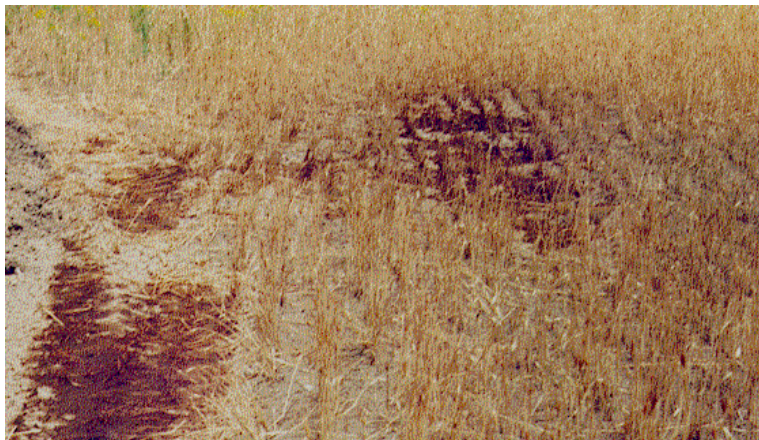
Photo No. 5: Parcel superficially contaminated by oil

Comments: Presence of crude oil on the surface of the soil. The contaminated surface is not more than 1000 square meters (photo 5)

(00-03 cm) Horizon very oily surface by crude oil - Color 7.5 YR 3 / 2 (dark brown) - compact little - texture silt and clay - little apparent structure - crusts drying on the surface - no activity Biological - low organic matter - positive reaction with HCl attesting to the presence of calcium in the form of calcium carbonate (CaCO_3) - $\text{pH}_{\text{H}_2\text{O}} = 7,18$ - $\text{pH}_{\text{KCl}} = 6,76$

(03 - 25 cm) Horizon oil cooler and by crude oil - 10 color YR 6 / 2 (light brownish gray) - compact - low organic matter - silty clay texture - polyhedral structure weak - no activity Biological - positive reaction with HCl demonstrating the presence of calcium in the form of calcium carbonate (CaCO_3) - $\text{pH}_{\text{H}_2\text{O}} = 7,25$ - $\text{pH}_{\text{KCl}} = 7,02$

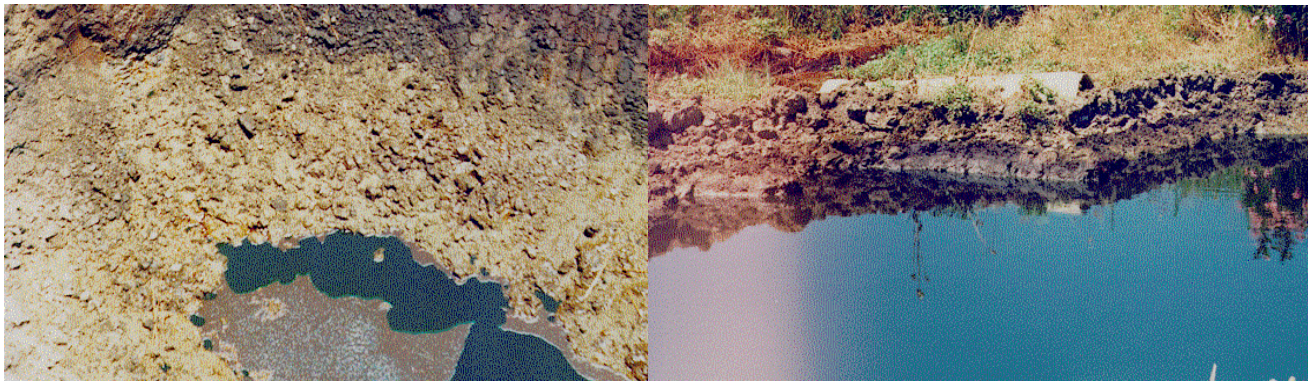
Photo N° 6 -7: Presence of crude oil in the excavation conducted in the basement and in the wadi

Comments: None presence of crude oil along the cultural profile by the excavation of the basement conducted by SONATRACH, to a depth of 3 to 4 meters, evidenced by its presence. Crude oil is much more present on the surface of the water in the wadi chaabet Lebane adjacent to the farm. (Photos 6-7)

We have also noted the presence of crude oil in Lebane chaabet wadi next to the operating EAI No. 7. Being less dense than water, crude oil formed on the surface a thin layer oily.
